**PIERS 58, 59 AND 60 TIMBER PILING INSPECTION
(WC1741)**

December 2016

City of Seattle
Department of Parks and Recreation
Planning and Development Division
800 Maynard Avenue S, 3rd Floor
Seattle, WA 98134-1336

Seattle Structural PS Inc.
3131 Elliott Avenue, Suite 600A
Seattle, WA 98121

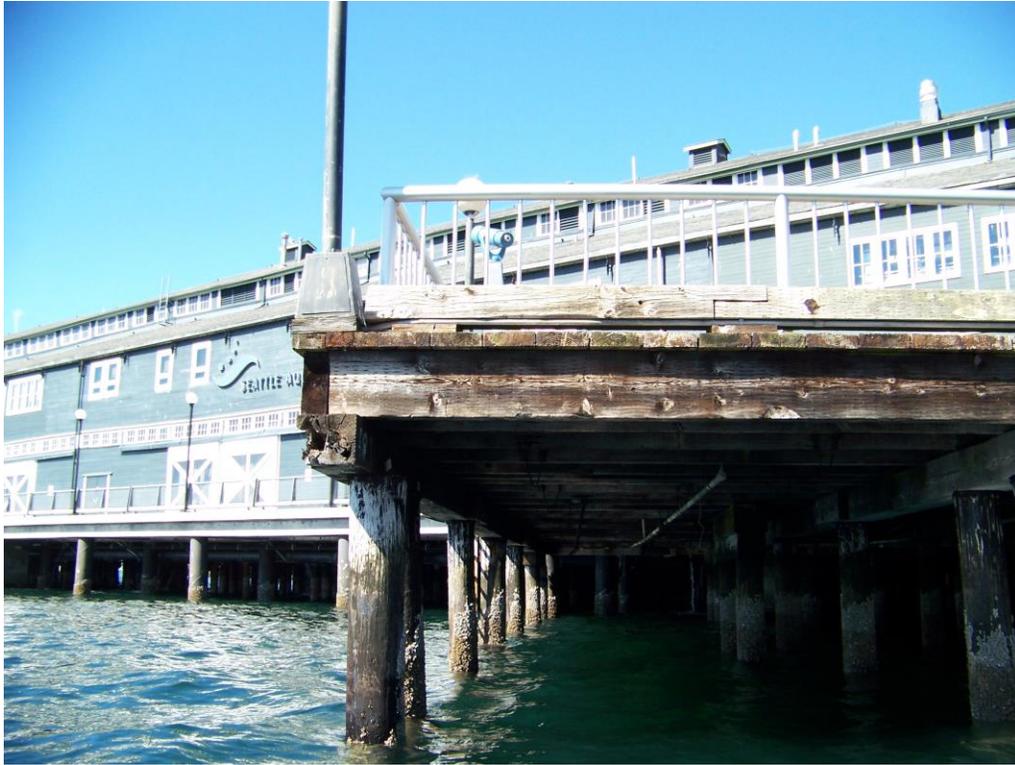
Photo 1: Pier 58 general condition of timber structure

The timber pile caps are above the splash zone and have no significant surface rot and no observable marine borer activity. The ends of some caps at the edge of the pier look “weathered” but they have no significant loss of capacity as the damage that exists is in a region of low stress. A pile cap near Grids 3/U has an inclined crack that has not changed significantly since 2006. The timber pile caps generally are in satisfactory condition. Typical conditions are shown in photos 1 and 2.

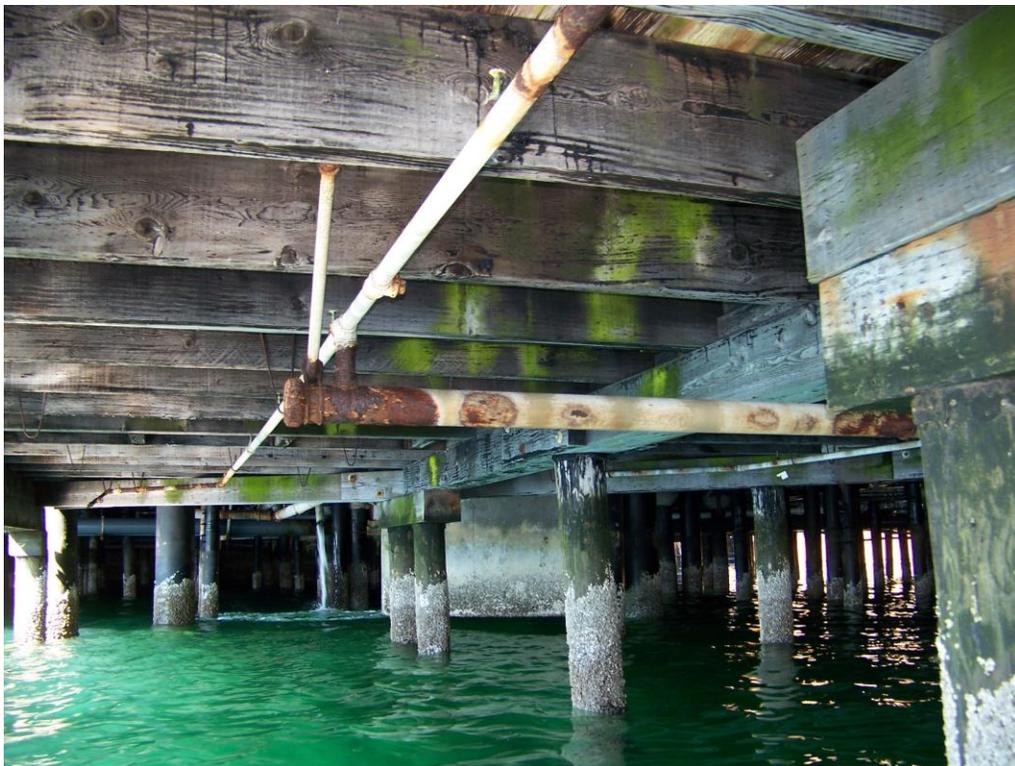
Photo 2: Pier 58 general condition of timber structure

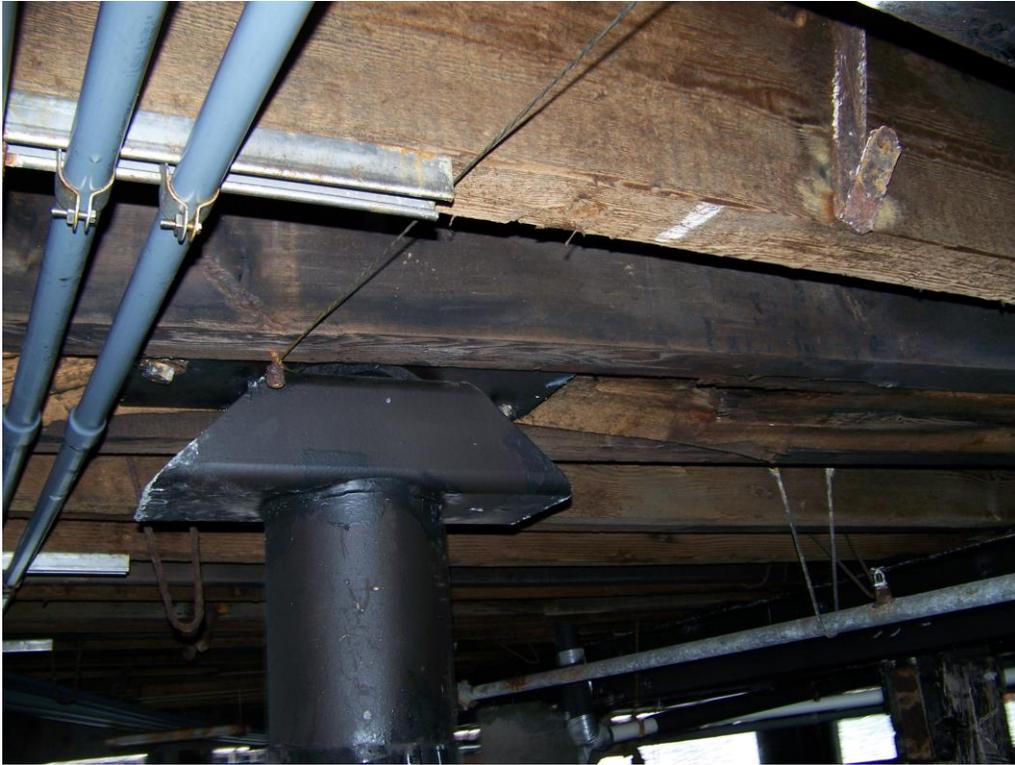
Photo 3: Pier 59 crushed timber beam at pile N2-28 (looking north)

Piles N2-28 and N2-29 support timber beams that are partially rotted and crushed, see photos 3 and 4. This damage was reported by BergerABAM in 2015. These beams and piles support the tall west wall of the Aquarium building. No significant signs of movement were observed above the decking inside the building and none were reported by Aquarium staff. This condition does not appear to be a source of imminent failure.

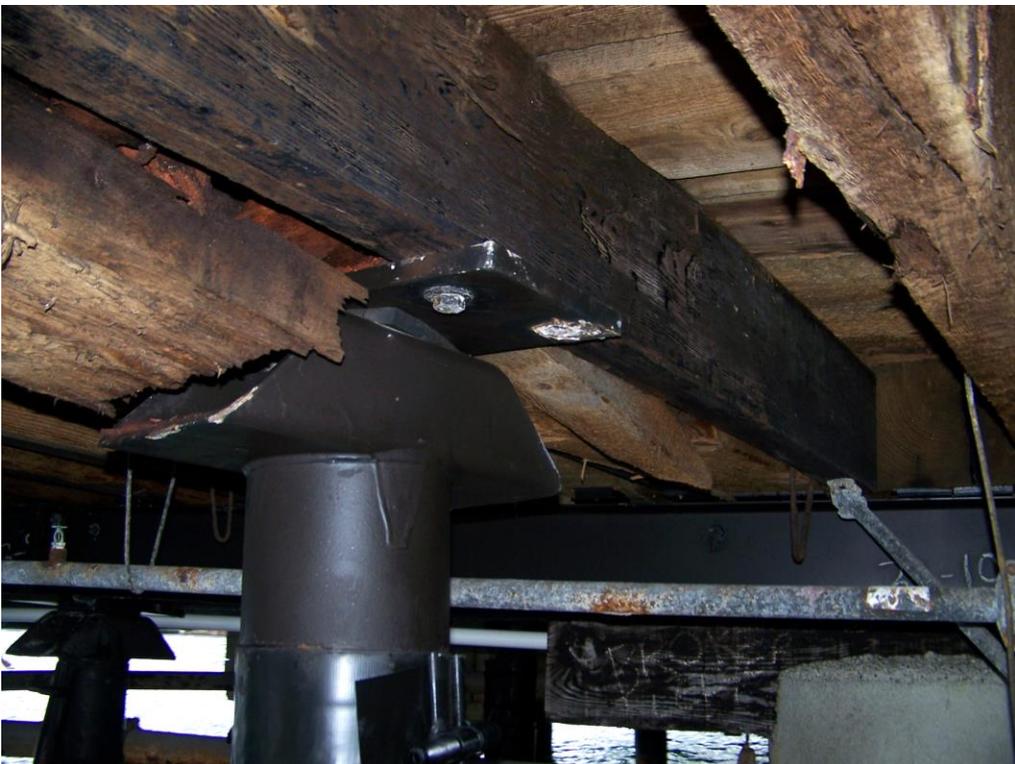
Photo 4: Pier 59 crushed timber beam at pile N2-29 (looking north)

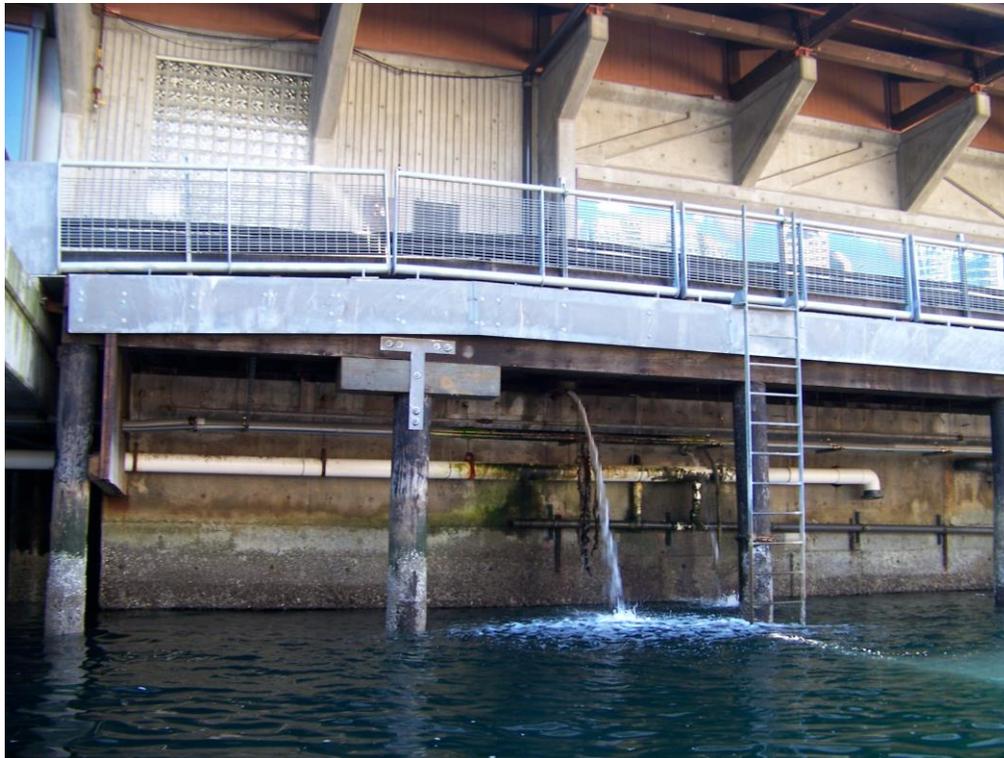
Photo 5: East side of Pier 60 at the Triangle

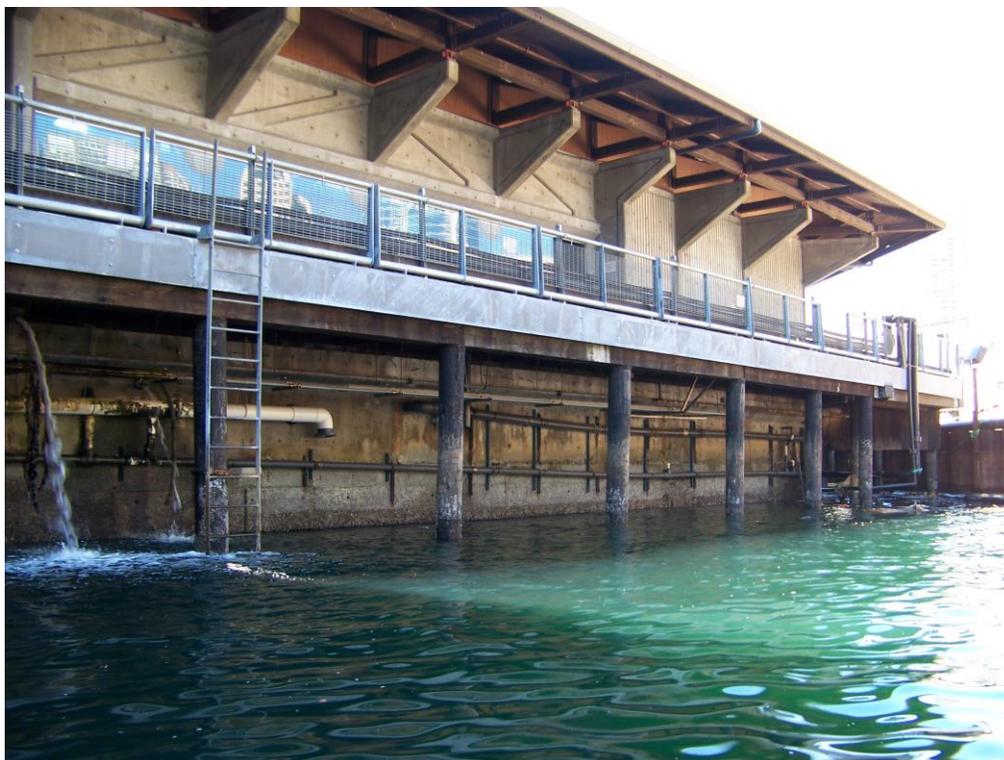
Photo 6: East side of Pier 60 at the Triangle

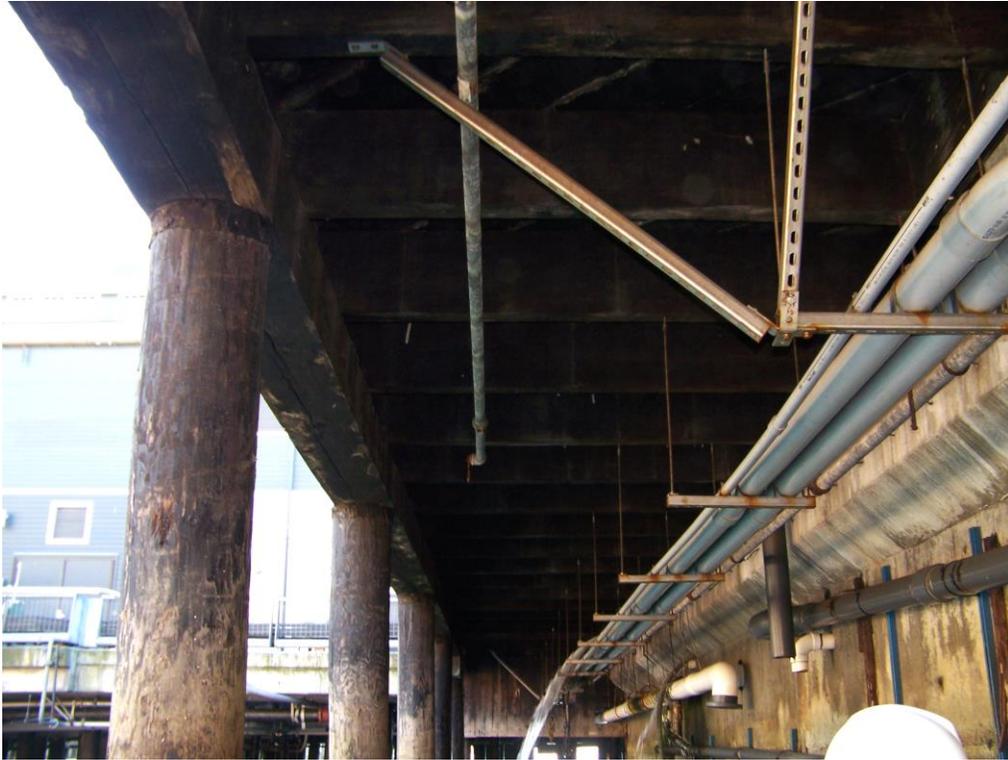
Photo 7: East side of Pier 60 recent modifications (looking south)

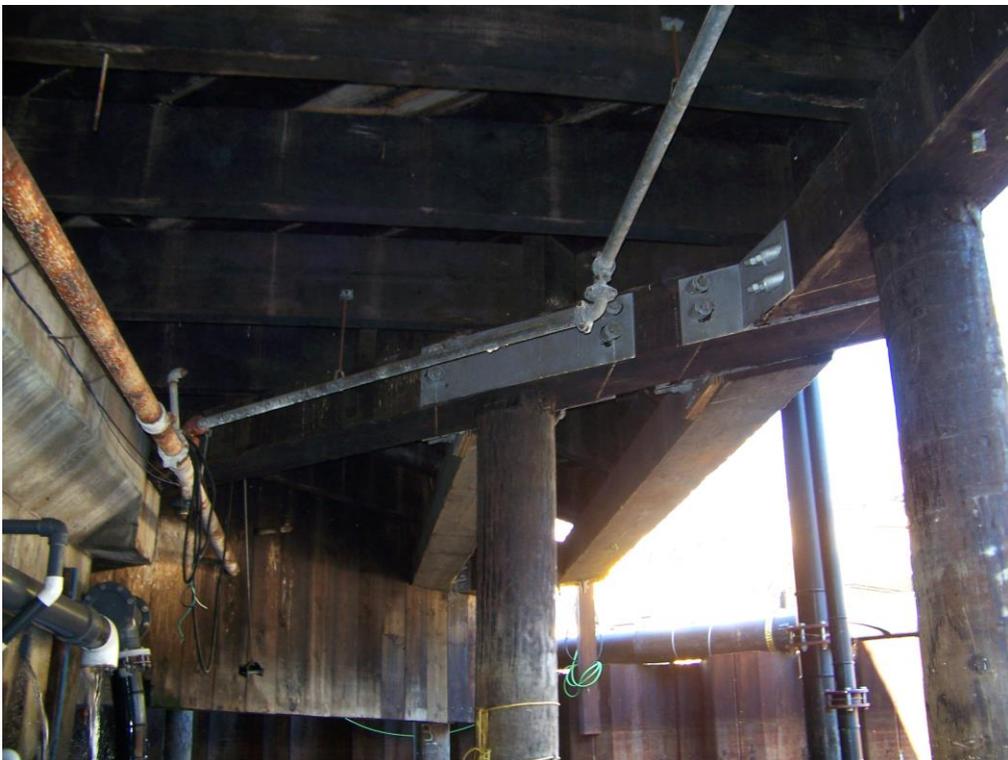
Photo 8: East side of Pier 60 recent modifications (looking north)
